STATE OF MARYLAND
OFFICE OF THE ATTORNEY GENERAL
JUVENILE JUSTICE MONITORING UNIT

**CHELTENHAM YOUTH FACILITY
SPECIAL REPORT**

Date of Investigation: August 10 – 19, 2008

Date of Report: October 2, 2008

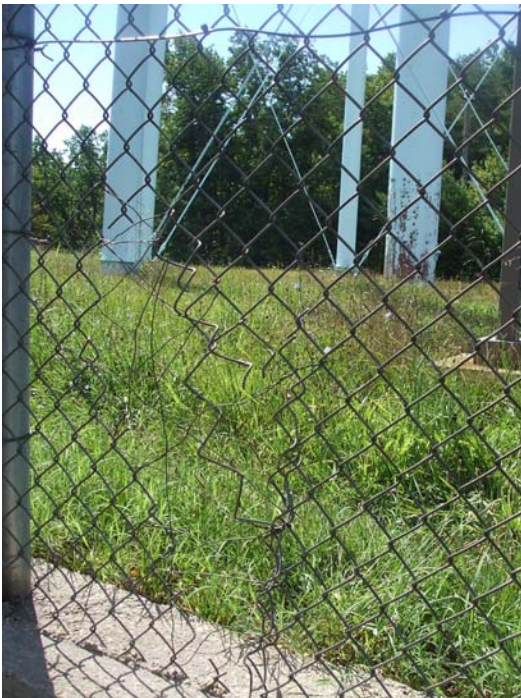
- Parental/guardian notifications were reportedly completed to the best extent possible.
- There is no camera surveillance around the area of fence where the youth cut through and escaped, according to the Facility Administrator.
- The fence alarm was triggered by the escapees but the alarm went unheeded by staff. The problem of false alarms generated by the fence sensors has been an ongoing issue noted in prior reports from this Office and in a DJS Quality Review report on CYF completed on May 16 of this year.

To resolve the problem, the Department purchased an entirely new fence security system for Cheltenham over the summer. Unfortunately, the new system was issuing alarms multiple times per day due to an oversensitive response to wind, animals, or other natural causes. That condition had continued for so long that staff often ignored perimeter alarms.

Following the escape, the sensitivity settings for the fence system were recalibrated to reduce false alarms, and as of this writing, the volume of alarm trippings has reduced. Areas of the fence are still freezing at times on the computer screen – during visits on September 19 and 26, the Monitor observed portions of the fence frozen on the security computer screen. Work to stabilize the system continues.

Hole cut into fence during for the escape
