STATE OF MARYLAND
OFFICE OF THE ATTORNEY GENERAL
JUVENILE JUSTICE MONITORING UNIT

**CHELTENHAM YOUTH FACILITY
SPECIAL REPORT**

Facility: Cheltenham Youth Facility (CYF)
11001 Frank Tippet Road
Cheltenham, MD 20623
Acting Superintendent: Quanetta West

Date of Investigation: August 10 – 19, 2008

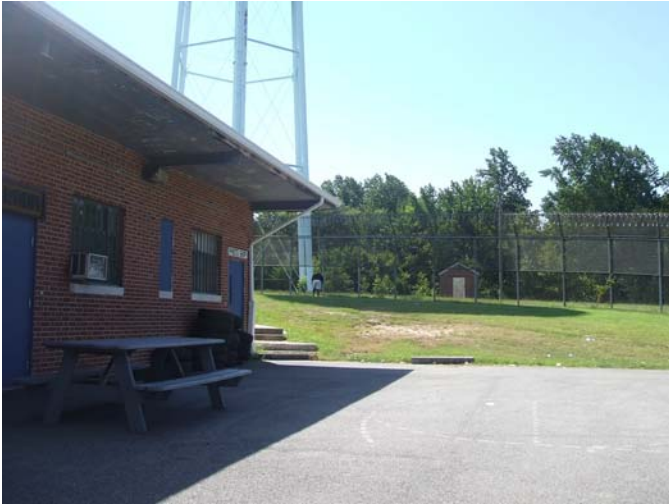
View from the Weight Room to the escape point at the fence

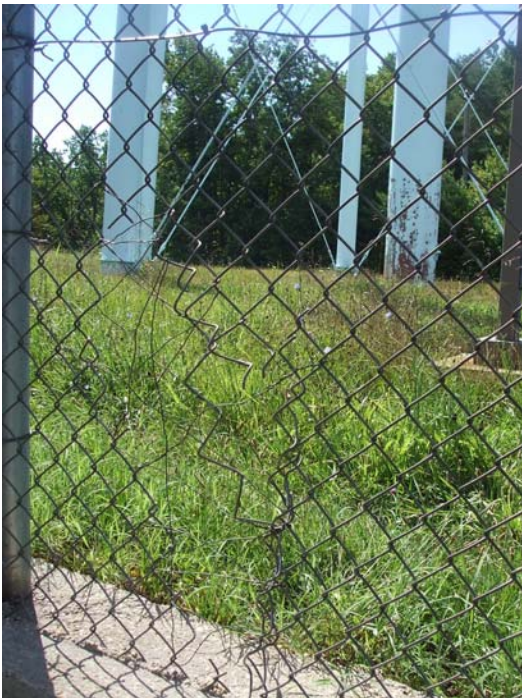
On August 10, 2008, at approximately 11:50 AM, three youth escaped from the facility. Staff did not notice when the youth walked away as they were moving from the weight room to the game room. From there, they fled to the east side of the campus, cut a hole in the fence, and escaped.

- A youth who did not take part in the physical escape said he provided a tool used to cut a hole in the facility fence. He said he felt his life was threatened because one of the escapees kicked him in the leg and told him "he'd better" steal cutters

from the school woodshop. According to the Facility Administrator and the youth concerned, the youth stole the cutters and handed them over to one of the escapees on Thursday, August 7. The cutters remained undetected until after the escape on Sunday morning.

Hole cut into fence during for the escape

- There is no camera surveillance around the area of fence where the youths cut through and escaped, according to the Facility Administrator.
- The fence alarm was triggered by the escapees but the alarm went unheeded by staff. The problem of false alarms generated by the fence sensors has been an ongoing issue noted in prior reports from this Office and in a DJS Quality Review report on CYF completed on May 16 of this year.

To resolve the problem, the Department purchased an entirely new fence security system for Cheltenham over the summer. Unfortunately, the new system was issuing alarms multiple times per day due to an oversensitive response to wind, animals, or other natural causes. That condition had continued for so long that staff often ignored perimeter alarms.

Following the escape, the sensitivity settings for the fence system were recalibrated to reduce false alarms, and as of this writing, the volume of alarm trippings has reduced. Areas of the fence are still freezing at times on the computer screen – during visits on September 19 and 26, the Monitor observed portions of the fence frozen on the security computer screen. Work to stabilize the system continues.
